The MURVI Club Newsletter

Summer 2023

A Faulty Fridge

Webasto Wrestling

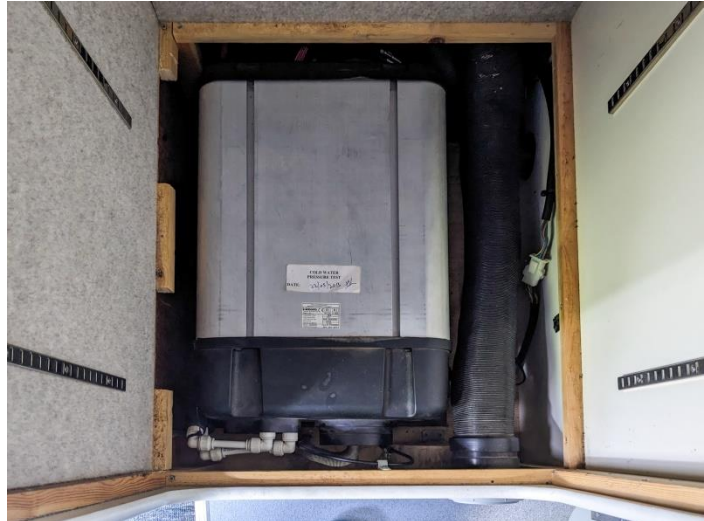
The picture above is slightly misleading as it shows two gaps in the frame on the left. I cut these after removing the heater and this made it much easier to refit the washers and nuts on this side. On first removal there were no such gaps but it was possible to get a 10mm socket onto the nuts and undo them. There are two nuts on each side which hold the heater onto rubber feet when must act to reduce noise transmission and vibration from the vehicle.

The Webasto of course lives at the bottom of the wardrobe or under the foot of the bed in the shorter wheelbase models. I have a suspicion Murvi may install it first then build the rest of the interior around it as at first glance it doesn't seem possible to get it out as there is virtually no space down the left hand side to reach the nuts which hold it in. I even considered trying to remove bits to improve access but short of removing the entire bed this wasn't a promising strategy.

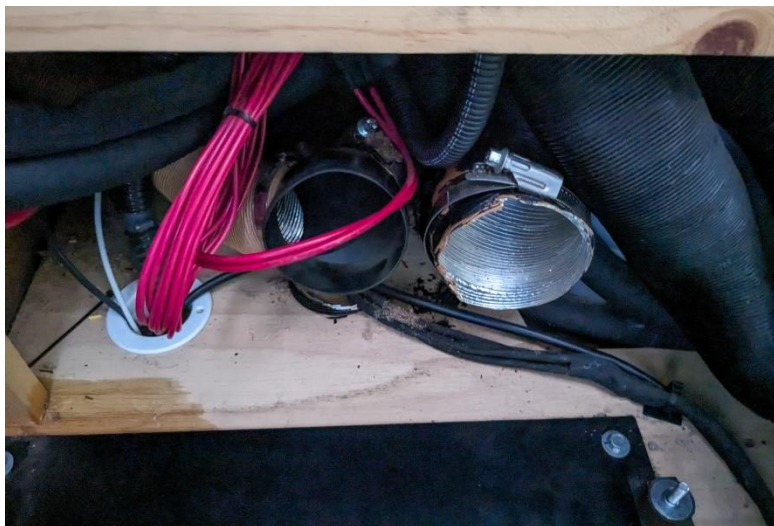
The last things to disconnect cannot be reached until you lift up the front of the heater and then pull it forward a short distance. This is easier to write than it is to do. You can now access where the two 80mm diameter foil-lined ducts connect at the rear of the heater. One takes air to the front and rear of the vehicle and one blows air out of the front of the wardrobe/bed. They are secured to the heater

by large clamps which can be undone but I then found Murvi had put in a sneaky self-tapping screw right through the end of the pipe and into the plastic connection on the heater. I am not sure how general these are but once identified they are easily removed. The photo above shows the left hand duct missing as it disintegrated during removal. The one on the right was still in one piece but it needed replacing having grown too brittle to survive handling. The ducting is available online.
